**UNIVERSITY OF CONNECTICUT  
GREATER HARTFORD CAMPUS  
West Hartford, Connecticut**

**LIMITED CONDITION SURVEY  
AND USABILITY/REUSE STUDY**

**September 10, 2003**

**S V I G A L S**  
**+ P A R T N E R S**

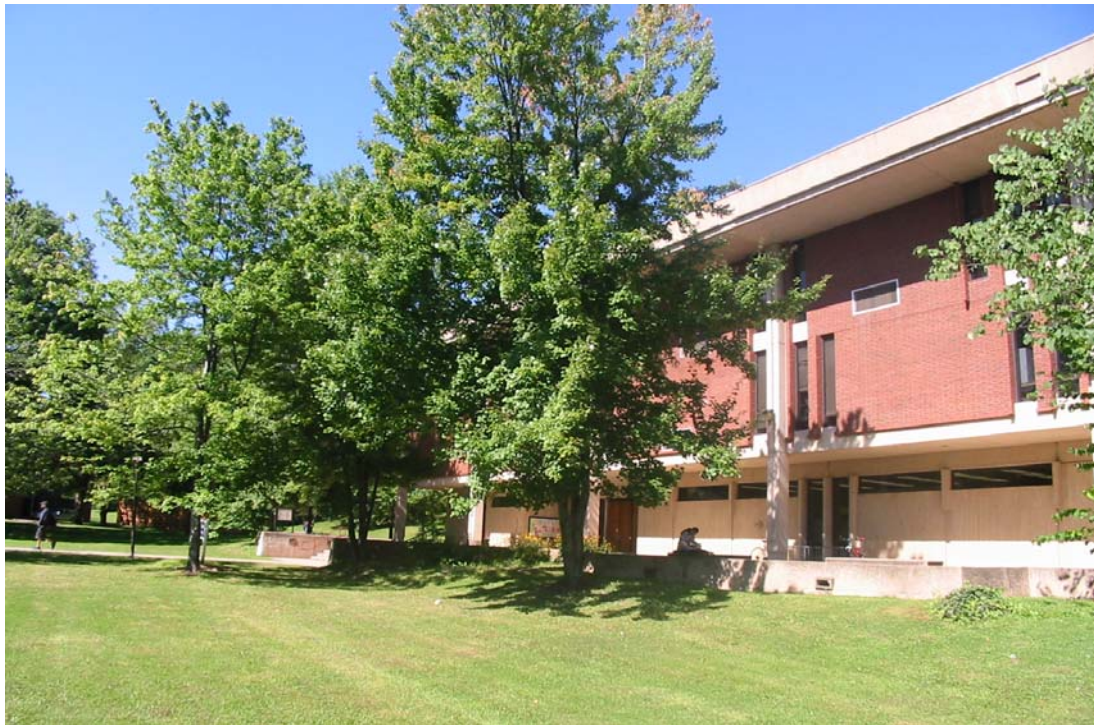
Typical Exterior Façades

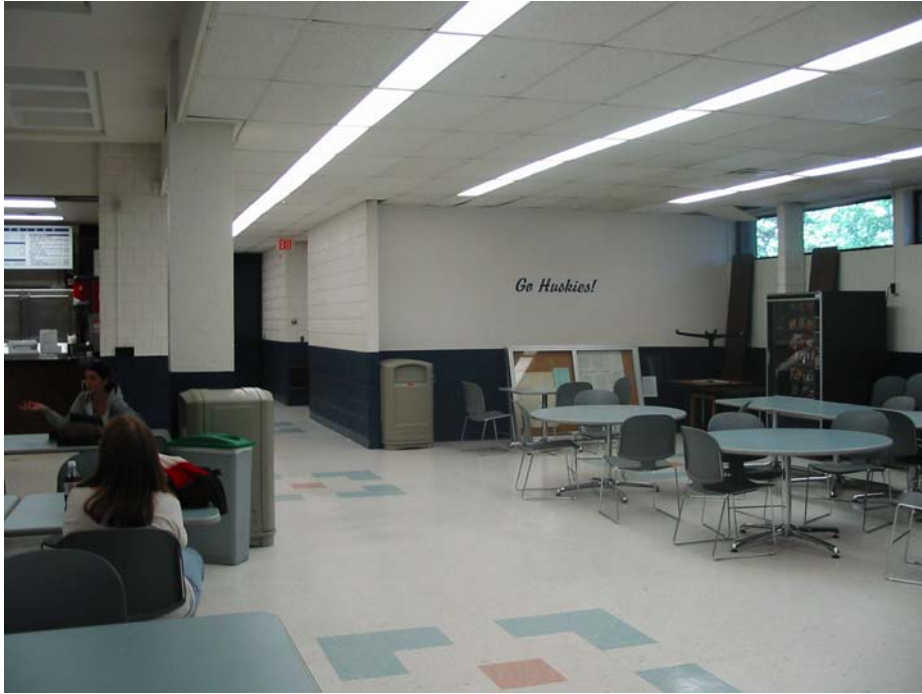
Food Service Area on 1<sup>st</sup> Floor

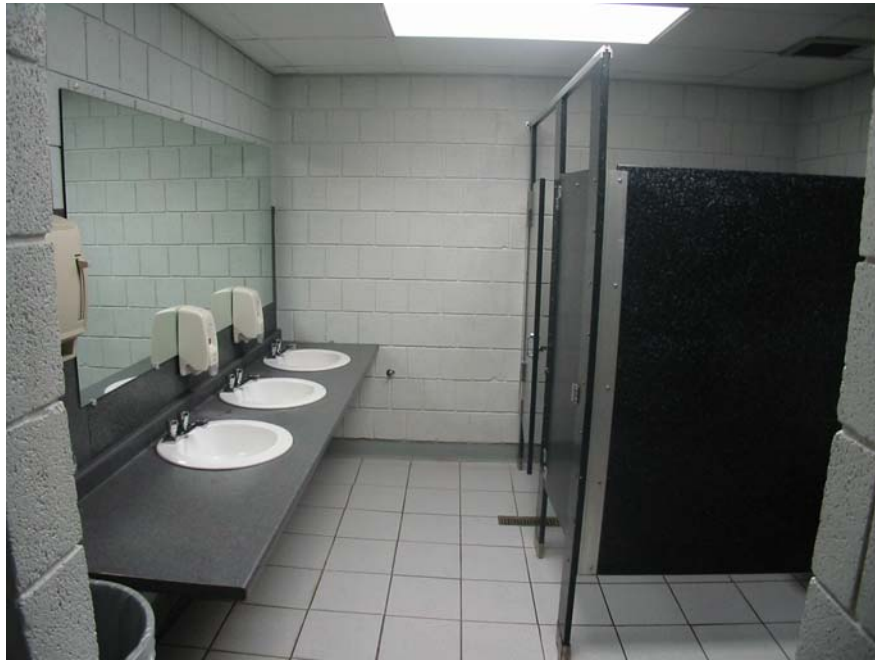
There were no obvious problems associated with the central plumbing systems; however several areas of concern were noted. Toilet rooms are in very poor condition and many fixtures need replacement. The acid resistant glass waste piping serving the labs needs a total replacement due to failure of the joint seals. The water supply and waste systems serving the cafeteria are undersized and most likely do not meet current Health Department requirements.

Typical Toilet Room

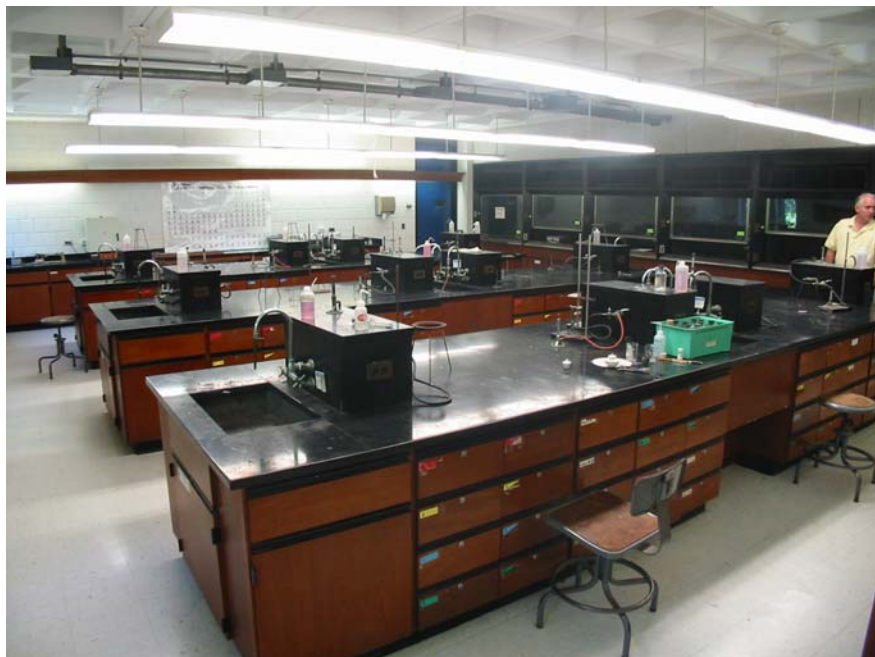
The three science labs have fume hoods, proper ventilation requirements could not be determined, but given the age of this building, most likely do not meet current lab ventilation requirements.

Science Classroom

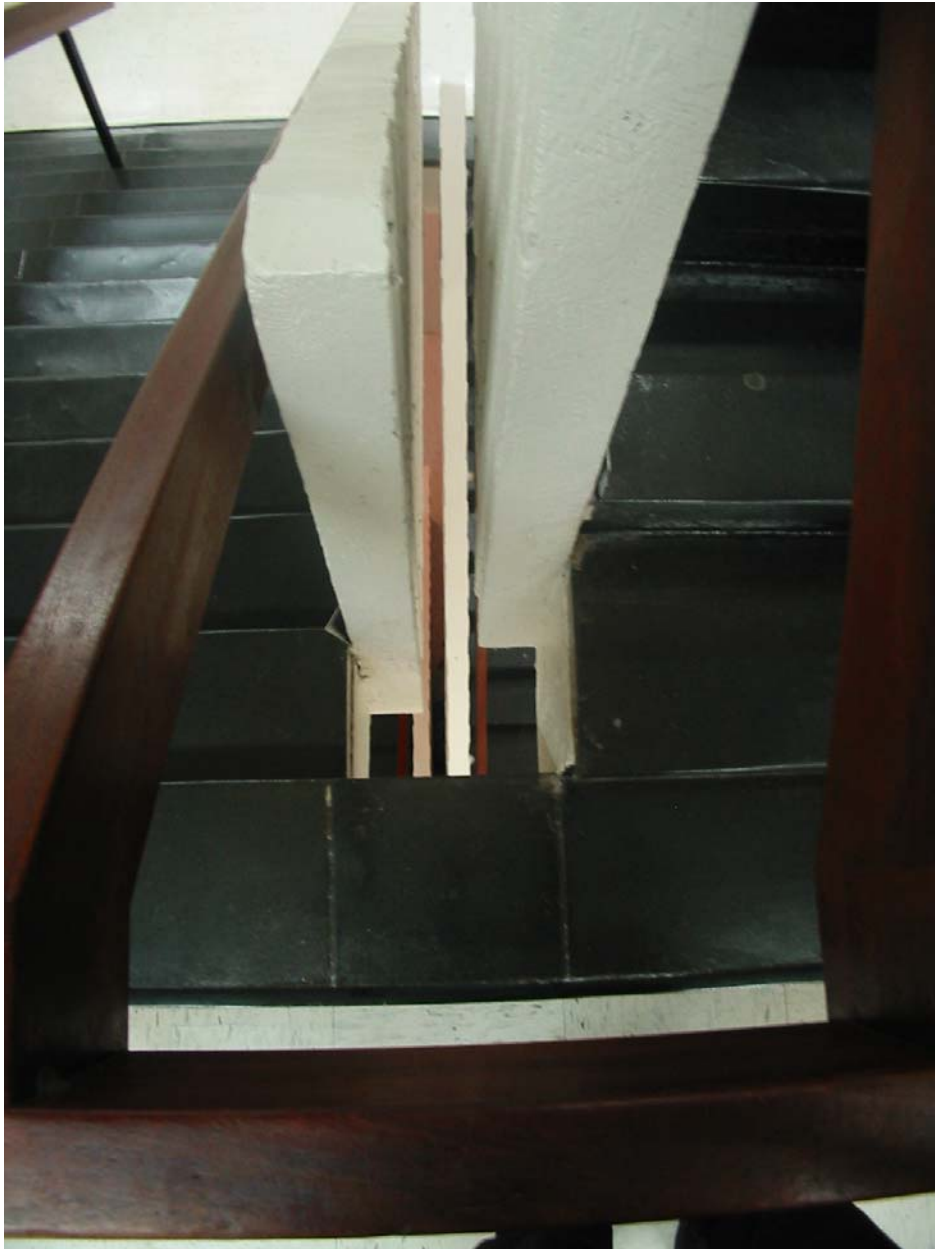
Typical Stair – Handrails and accessible openings do not meet current Codes.

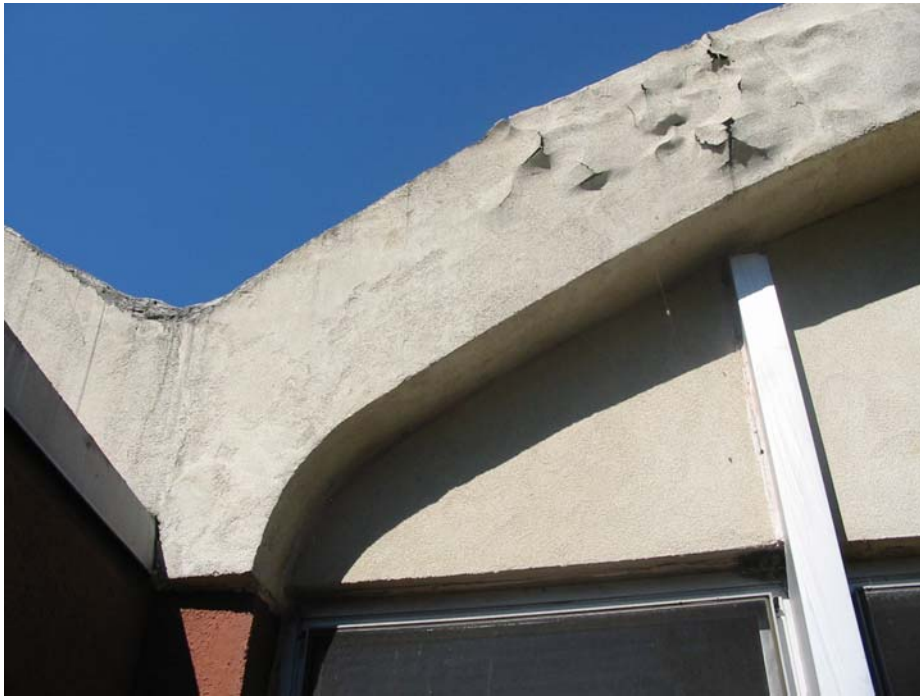
The exterior façade is composed of a "Dryvit" veneer finish system applied in recent years over the original plaster exterior. The windows are single pane and are at the end of their useful life. Numerous problems with air and water infiltration exist. The new veneer finish system appears to be suitable for most of the façade; however, serious problems are apparent where the roof meets the wall. There does not appear to be adequate flashing to properly prevent water infiltration at this critical juncture and failure of the veneer system is readily apparent. There is also damage to the veneer system adjacent to the ground, due to either water infiltration and/or landscape maintenance operations.

Exterior Façade Deterioration

The repair of the exterior façade and roof will present a significant challenge for any facility reuse. We would anticipate a complete removal of the existing exterior enclosure and design of a new roof and skin which would address the water infiltration and flashing issues addressed above.

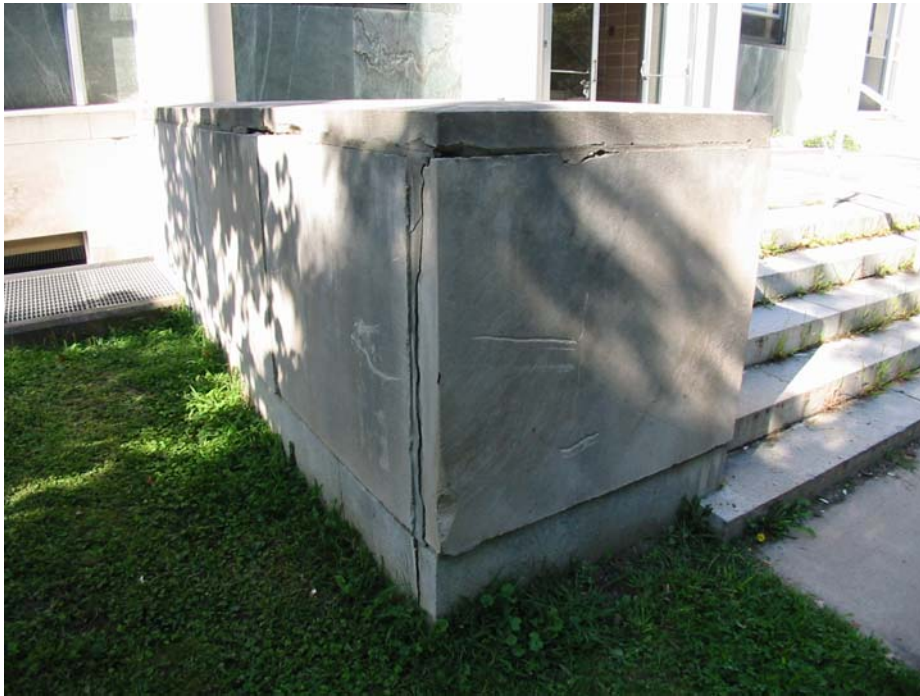
The exterior façade is masonry veneer with pre-cast concrete trim elements. There are also some areas of stone veneer at the front entrance. The windows are single pane and are at the end of their useful life. A few areas of the precast concrete trim and panel areas have experienced severe deterioration due to water infiltration and the resulting freeze-thaw damage. Other areas have been damaged by vines which, while now removed, have caused damage. There is considerable damage to the concrete areaways on all sides of the building. The brick veneer on the auditorium addition also has considerable spalling of its outer surface. Water infiltration is also evident on the interior around the windows in many of the spaces.

Exterior Deterioration

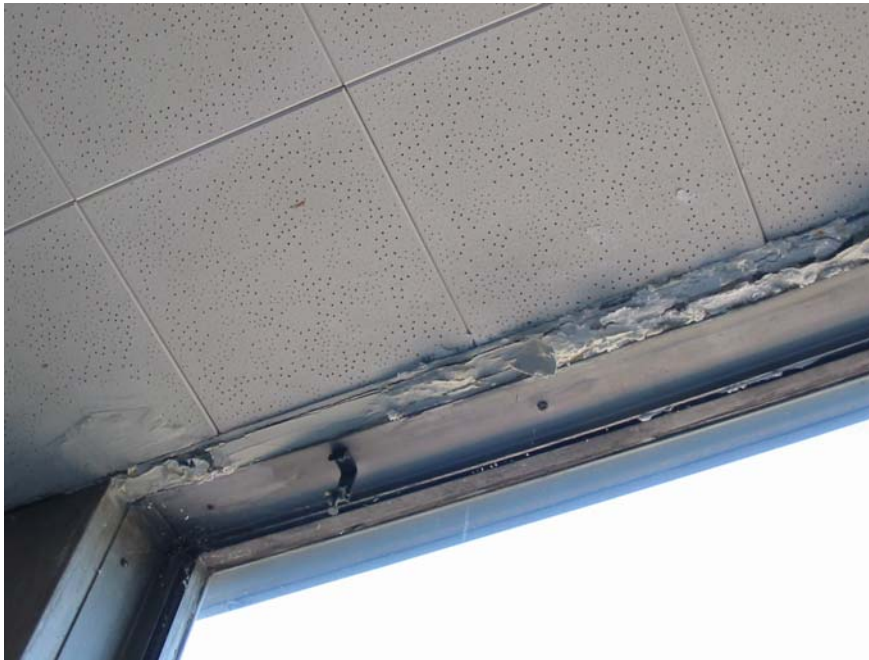
Water Damage at Window Head

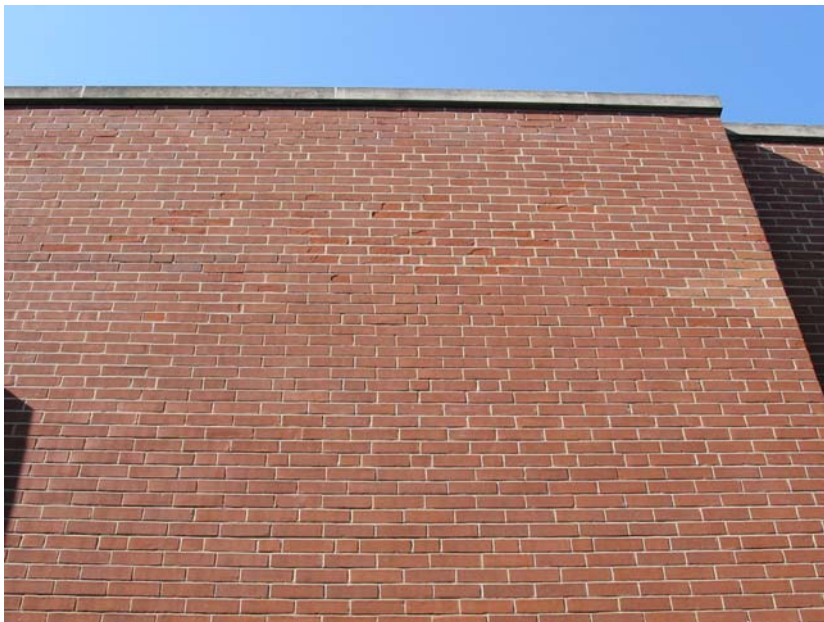
Spalling Bricks on Auditorium Addition
