Greater Hartford Campus Master Plan

November 2004

**UNIVERSITY OF CONNECTICUT
GREATER HARTFORD CAMPUS
West Hartford, Connecticut**

**LIMITED CONDITION SURVEY
AND USABILITY/REUSE STUDY**

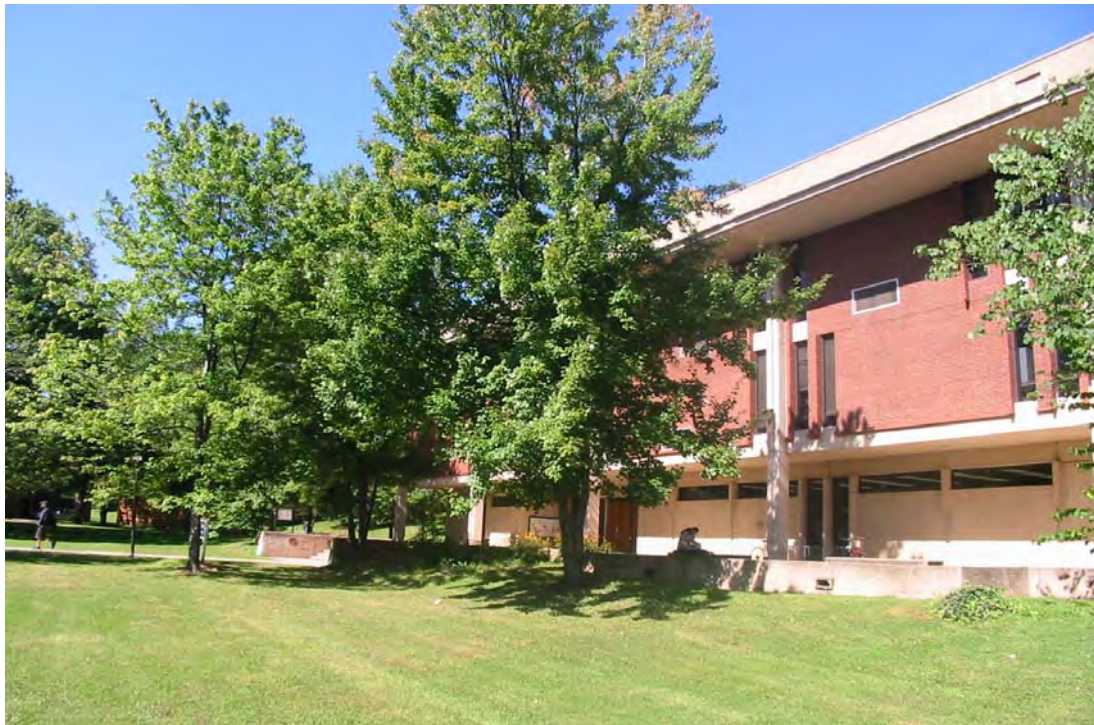
The exterior façade is composed of large expanses of brick veneer with exposed concrete "trim" elements, both of which appear to be in good condition. A few areas of brick need repointing and a few areas of the concrete trim are beginning to spall. Installation of new, and replacement of old through-wall HVAC units is apparent in the brickwork. The windows are single pane and are at the end of their useful life. The exterior plaster soffit at overhands also appears in good condition. A complete replacement of all caulking and sealants for the exterior should be considered at this time to extend the useful life of all building elements.

Typical Exterior Façades

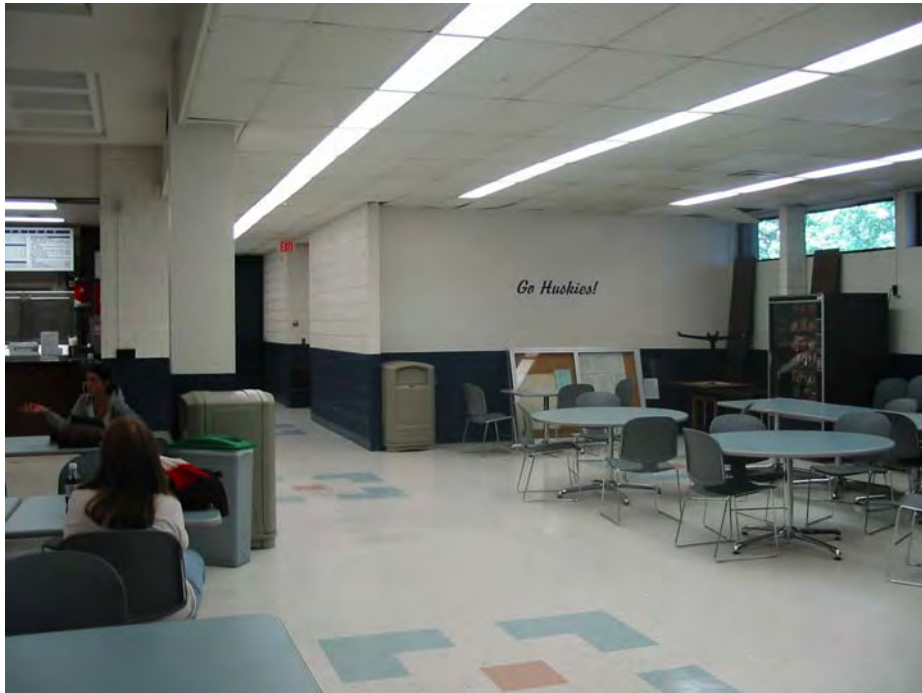
The facility does not adequately meet the campus needs for gathering space and food service. The cafeteria does not have adequate loading, storage or food prep areas to meet the student population. The areas for tables and casual gathering also need more space. The exercise area in the basement also appears to be undersized and overused.

Food Service Area on 1st Floor

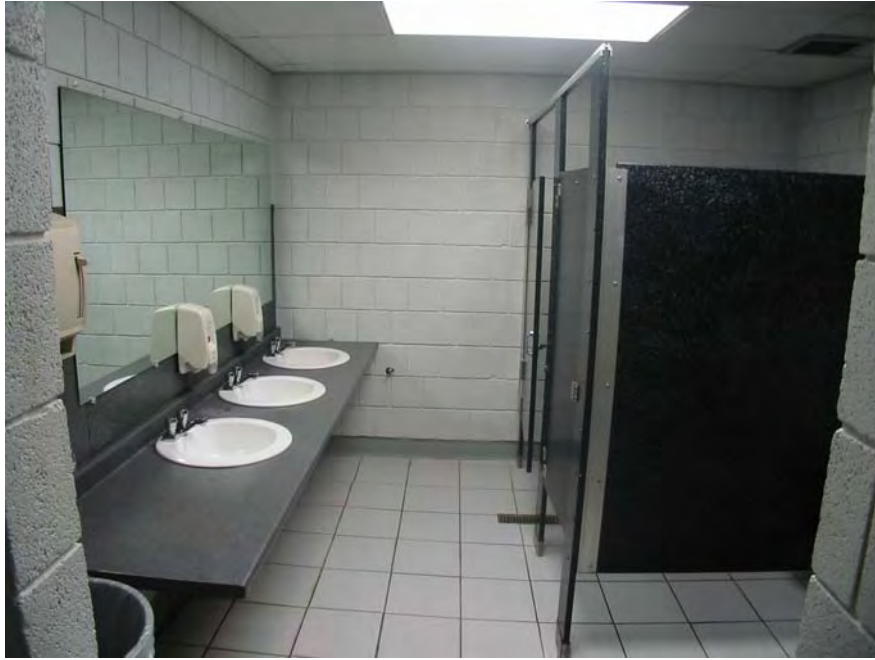
There were no obvious problems associated with the central plumbing systems; however several areas of concern were noted. Toilet rooms are in very poor condition and many fixtures need replacement. The acid resistant glass waste piping serving the labs needs a total replacement due to failure of the joint seals. The water supply and waste systems serving the cafeteria are undersized and most likely do not meet current Health Department requirements.

Typical Toilet Room

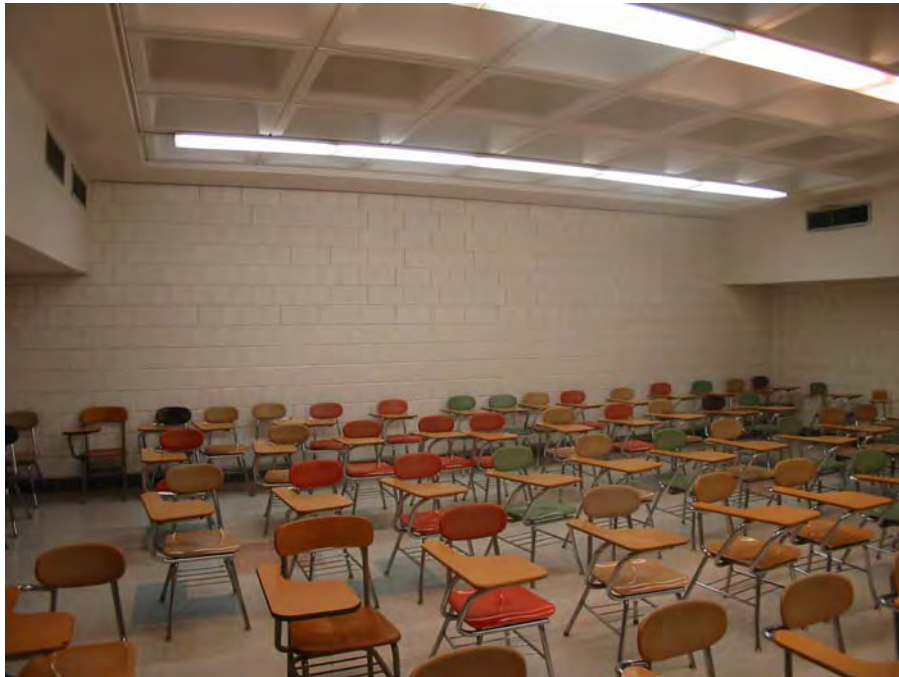
Classrooms have very limited data infrastructure, usually only one drop per room. Technology use appears to be limited to overhead projectors and television/VCR on moveable carts. One high tech classroom was observed with video projection and additional data connections.

Typical Classroom

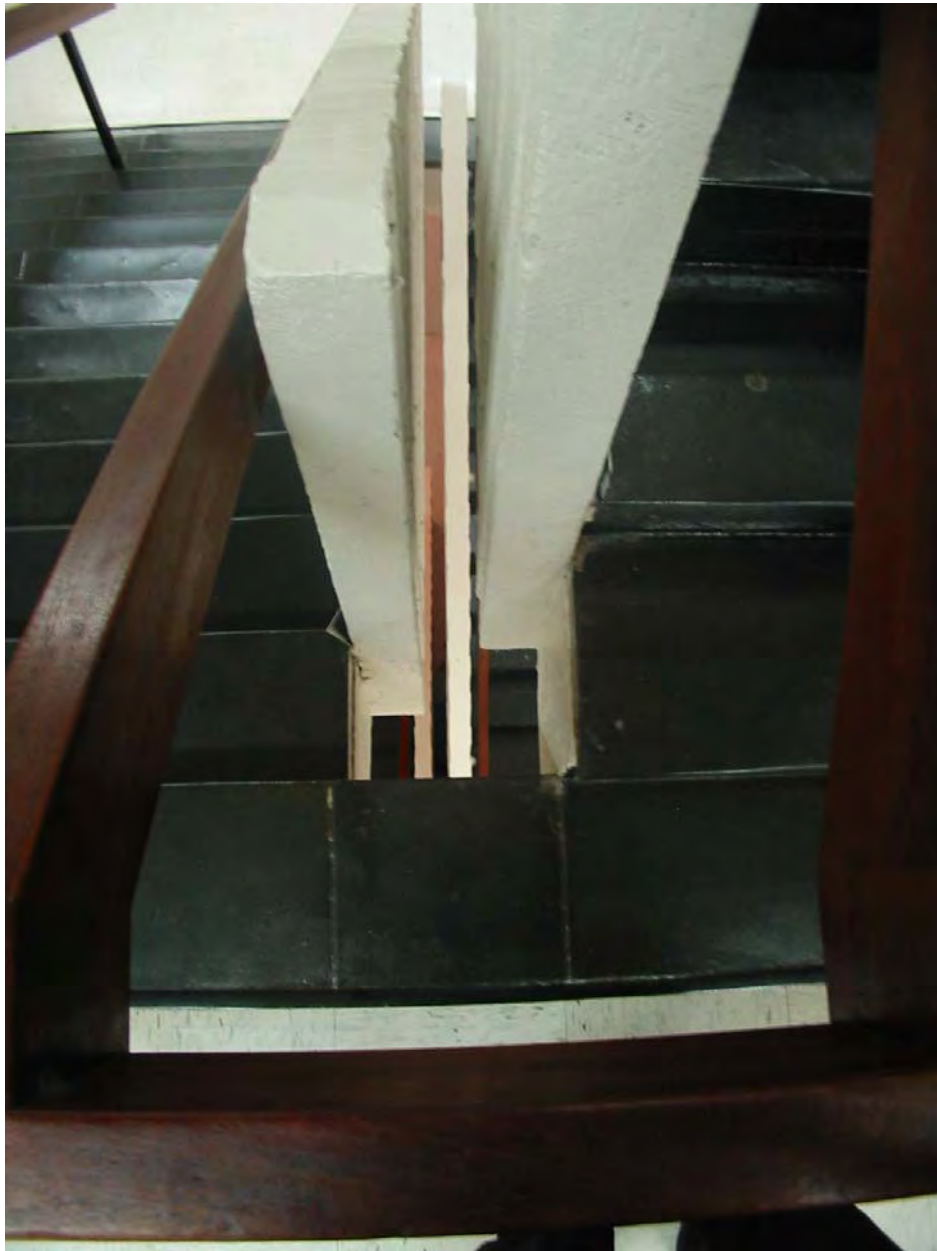
Typical Stair – Handrails and accessible openings do not meet current Codes.

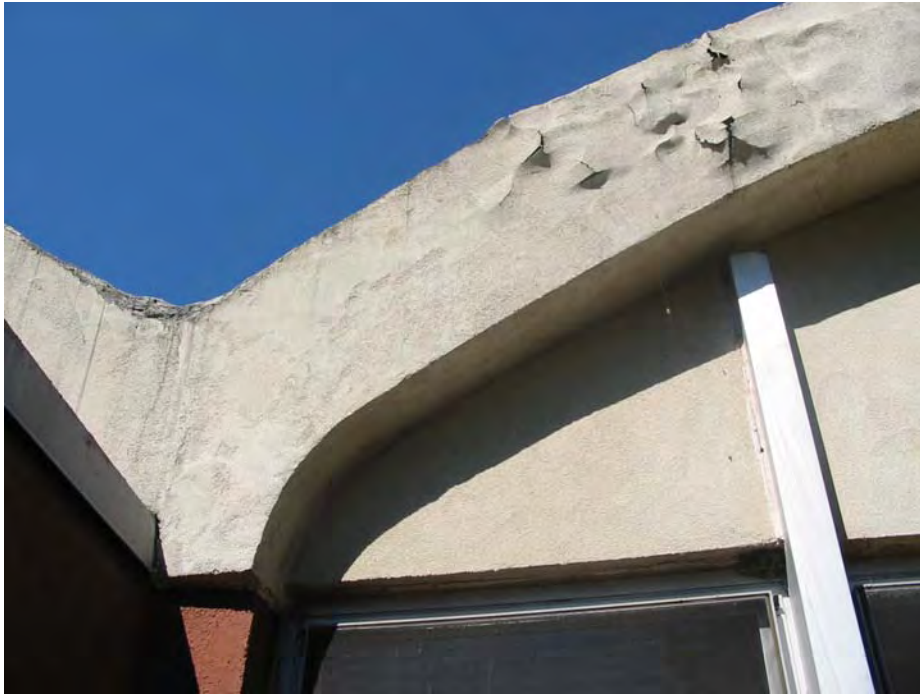
Exterior Façade Deterioration

The repair of the exterior façade and roof will present a significant challenge for any facility reuse. We would anticipate a complete removal of the existing exterior enclosure and design of a new roof and skin which would address the water infiltration and flashing issues addressed above.

A renovation of this magnitude, both interior and exterior, would most likely exceed the cost of demolition and new construction, the latter of which could yield a much more functional and flexible modern educational facility.

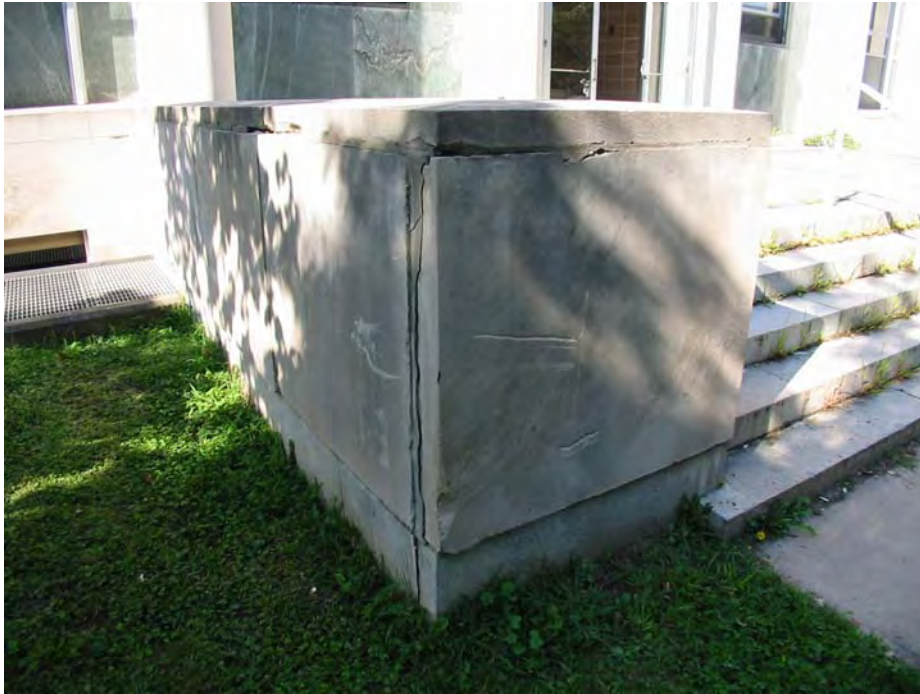
Exterior Deterioration

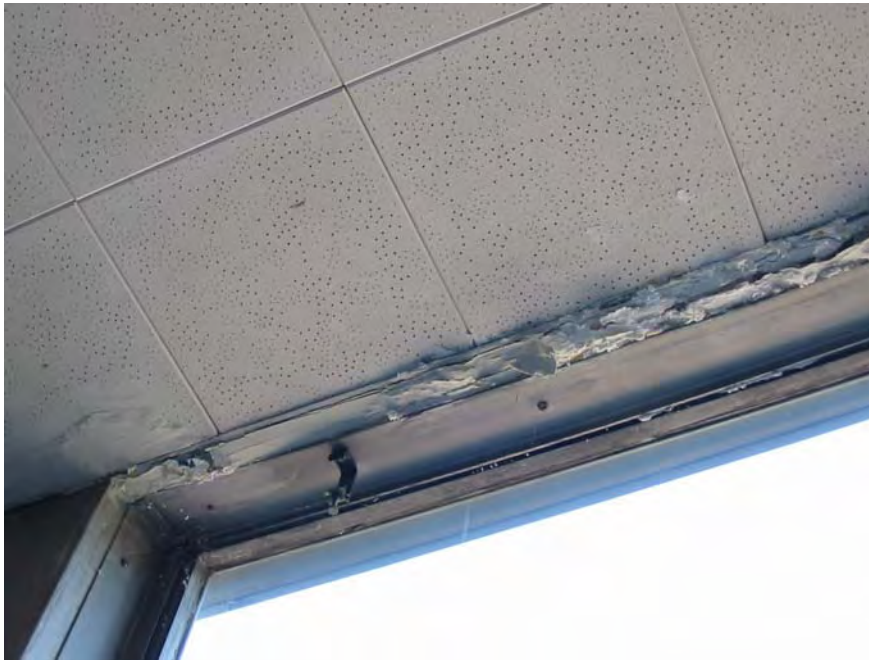
Water Damage at Window Head

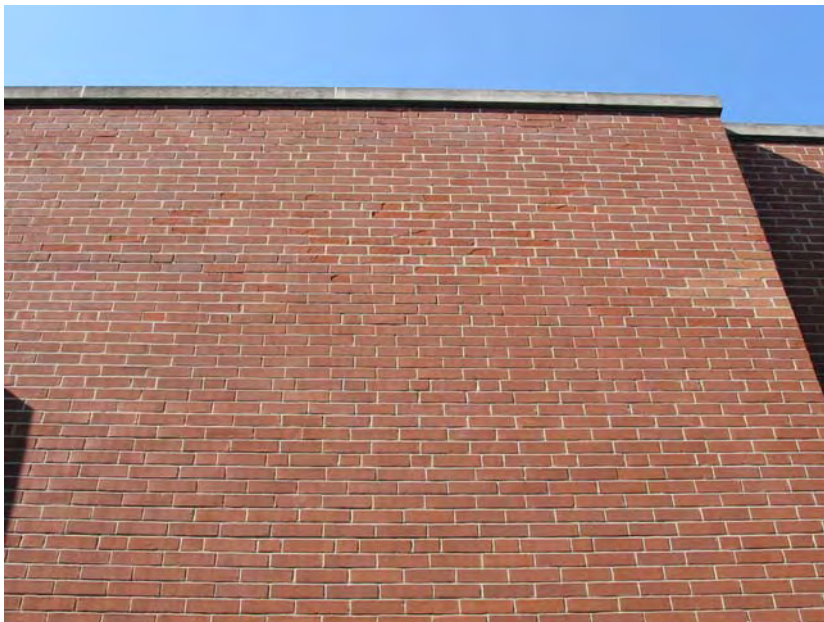
Spalling Bricks on Auditorium Addition
